IOWA STATE PATROL
OFFICE OF TECHNICAL INVESTIGATION
AND RECONSTRUCTION

DPS #: 2021018816 FILE: 21-086

SUBJECT: Two Vehicle Collision, Single Fatality
DATE / TIME: Wednesday, August 4th, 2021, at 2135 Hours (9:35 pm)
LOCATION: Interstate 35 NB-141 MM, Hamilton County, Iowa
DRIVER #1: Nessa, Anthony Roger DOB: 11/19/1959 (61)
1675 210th St SEX: Male
Webster City, IA 50595 DL#: IA 540XX6646 (IA)
VEHICLE #1: 2007 International 4300 SBA, White
IA LIC: DJX140 VIN: 1HTMMAALX7H469549
OWNER #1: Tony's Tire Service Inc
340 Closz Dr
Webster City, IA 50595
DRIVER #2: Bergert, James Alfred DOB: 11/15/1962 (58)
3160 220th St SEX: Male
Williams, IA 50271 DL#: IA 222CC1406
VEHICLE #2: 2000 Suzuki Grand Vitara, Red
IA LIC: EQV563 VIN: JS3TD62V2Y4128436
OWNER #1: Bergert, James
3160 220th St
Williams, IA 50271
VICTIM #1: Rizzo, Joanna Joyce DOB: 06/16/1970 (51)
3160 220th St DL#: IA 301WW6858
Williams, IA 50271 POSITION: Vehicle #2, Front Seat Passenger
ORIGINAL INVESTIGATOR: Trooper James Monroe #163
Iowa State Patrol, District 8

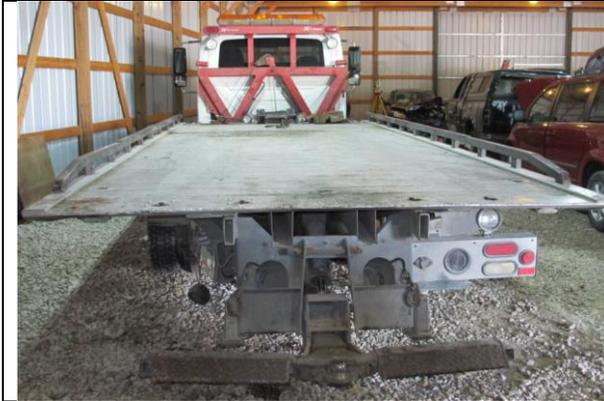
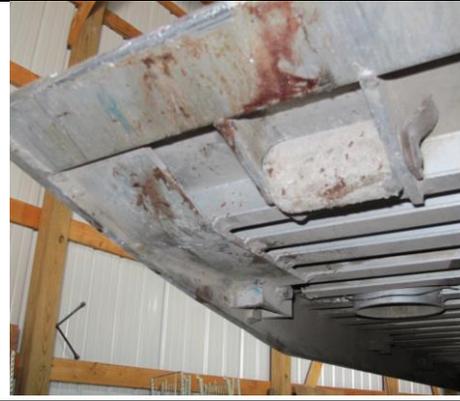
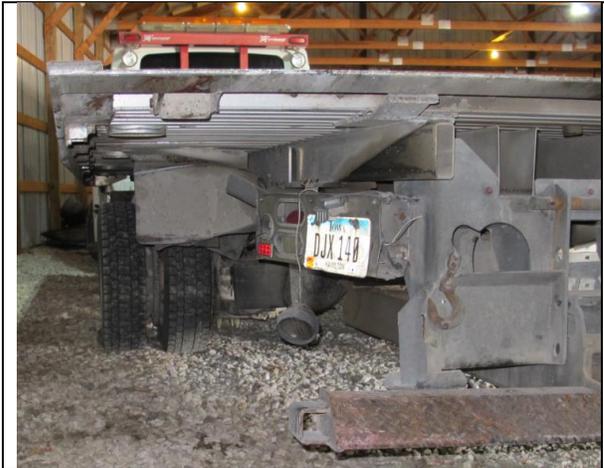
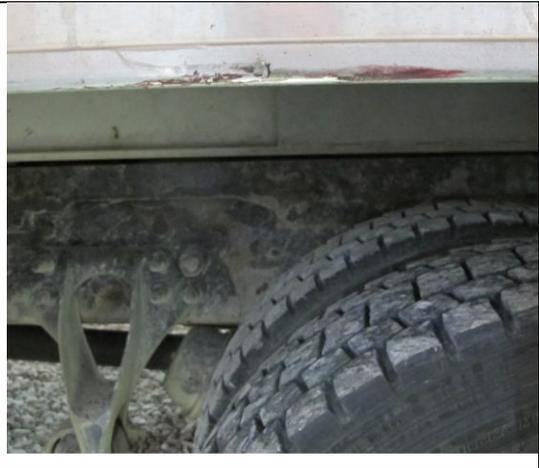
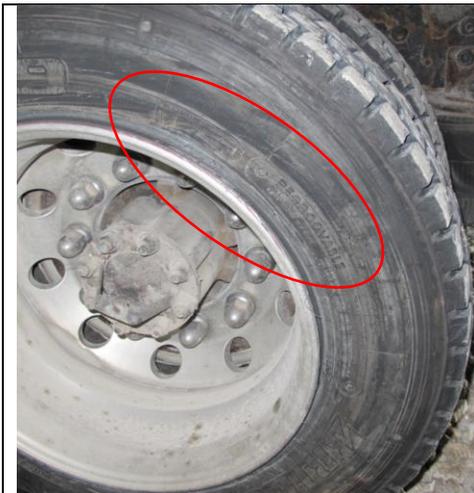
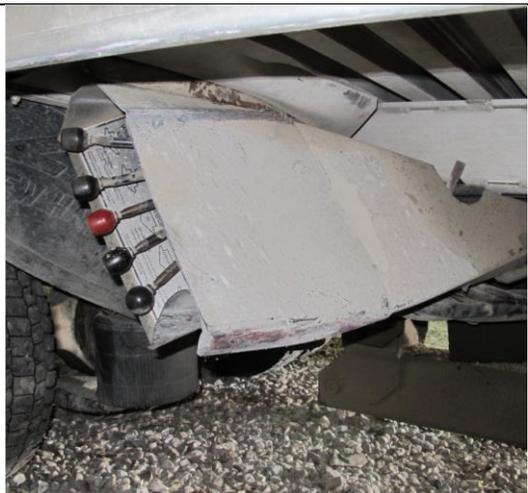
All the damage to the tow truck occurred to the rear of the vehicle. The left side of the vehicle is where the damage occurred. The rear outside tire on the driver's side was flat and the seal was broken from the rim. The tire was also punctured and had a hole in the tire. There was paint transfer on the rim from the Suzuki. There was also paint transfer on the flatbed on the driver's side. The taillight assembly

was bent forward and several lights were broken. The gear box with the levers that control the flatbed was bent and twisted forward. There was blood on the corner of the bed, both on top and underneath the flatbed.

Paint transfer from the Suzuki.

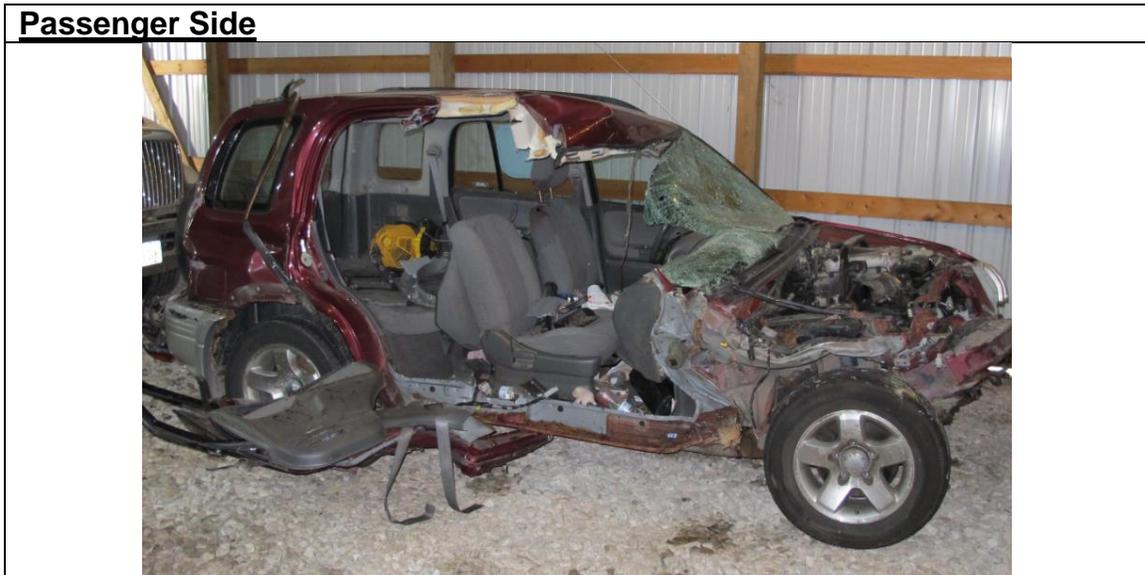
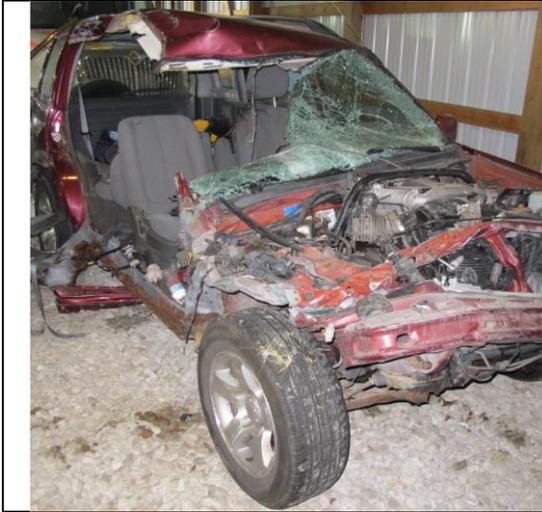
There was extensive front-end and passenger side damage to the Suzuki. The hood and front fender were torn from the vehicle. The flatbed of the tow truck cut through the windshield and the A-Pillar. The passenger side front and rear doors were removed from the vehicle as a result of the flatbed of the truck cutting through the vehicle.
